# **CASTING BASIN GATE MAINTENTANCE RECORDS**

CYCLE 6

# Kiewit-General Inspection Report

**PROJECT:** SR 520 PONTOONS

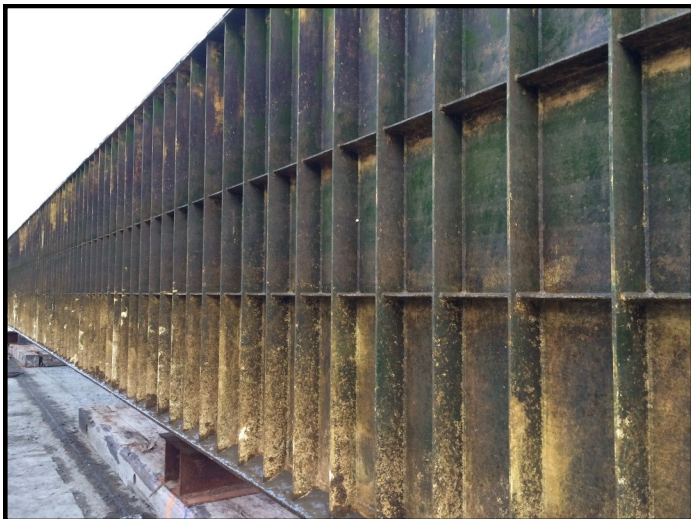
1) T2 before cleaning. Few to no barnacles found.

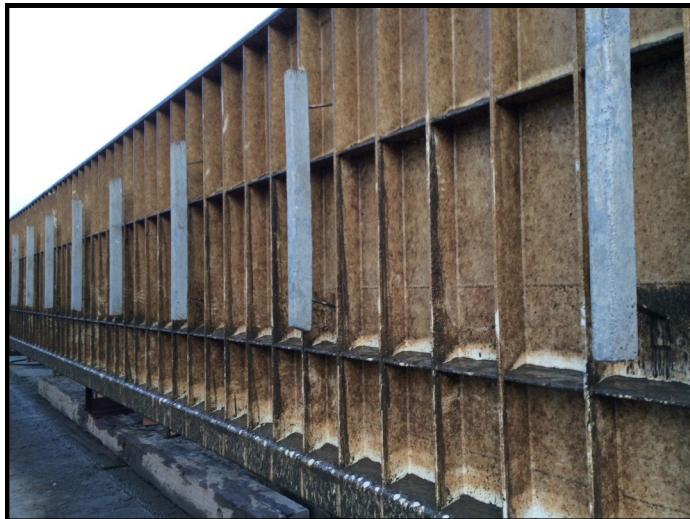
2) Aluminum anodes showing expected wear. Reference attached Norton inspection memo.

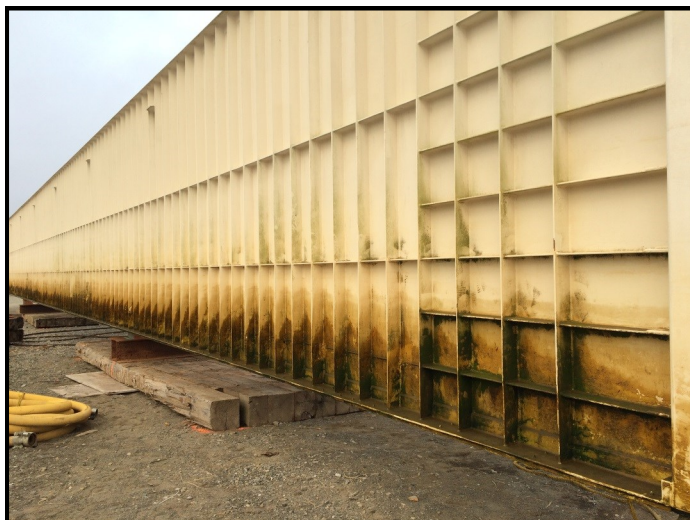
4) T3 before cleaning. Minimal marine growth or algae.

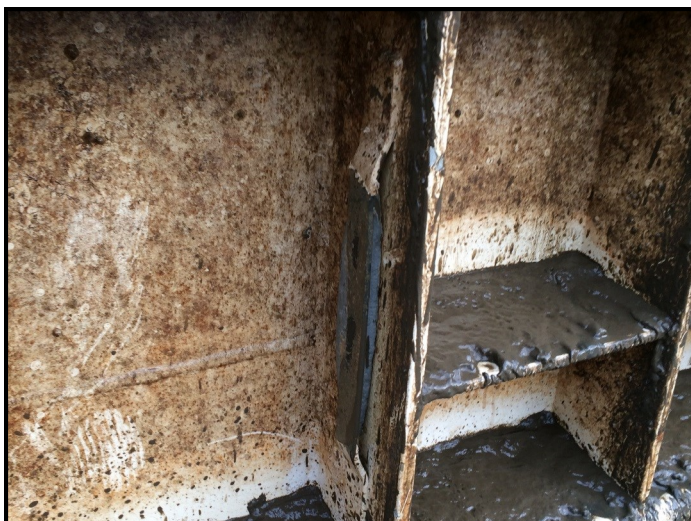
5) T1 zinc anodes nearing end of use.

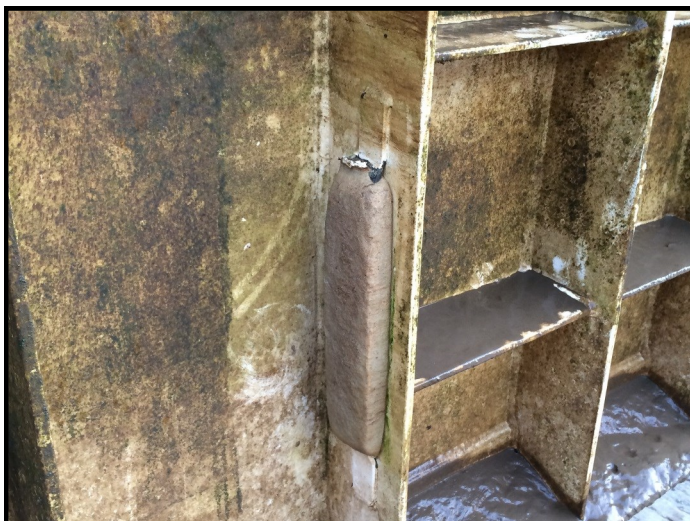
6) T2 zinc anode 60% remaining.

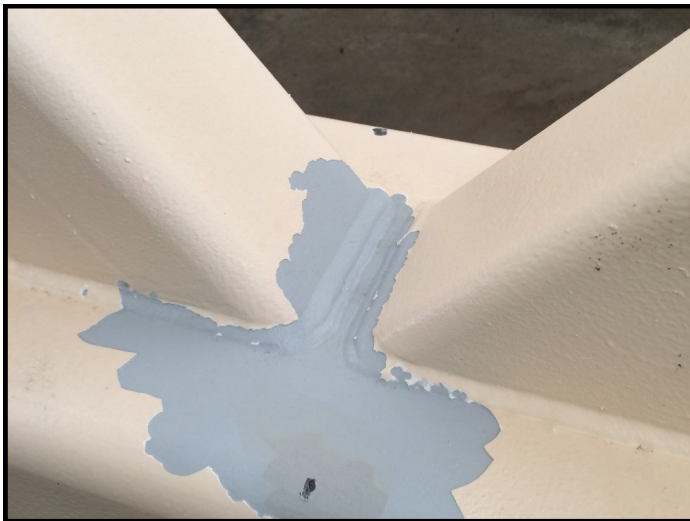
9) Large original Duraplate235 coating failure area down to primer from pressure washing.

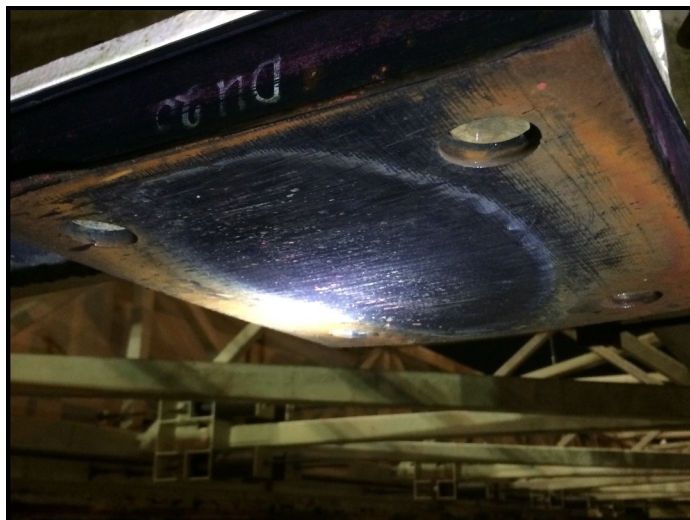
14) T1 bearing pad showing minimal wear. 1/4" of space to bolt heads

10. KG has stated that the gate UHMW feet were not fabricated to the required 3" dimension on the drawings. Based on the as-built height it appears that there is very little wear to these pads and there is still approximately 1/4" of material to the bolt heads. These items were previously noted to be replaced during the cycle 6 float out, however based on the new information on the wearing of the pads, replacement was not required, see **Photo 9**.

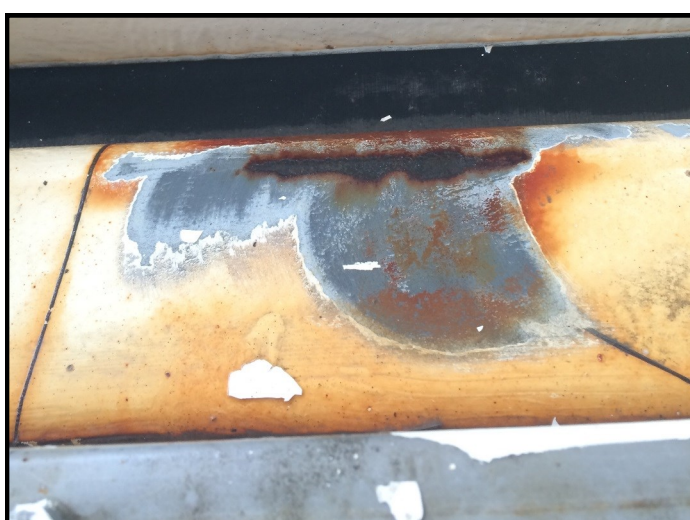
16) Previous repair never painted after prep.

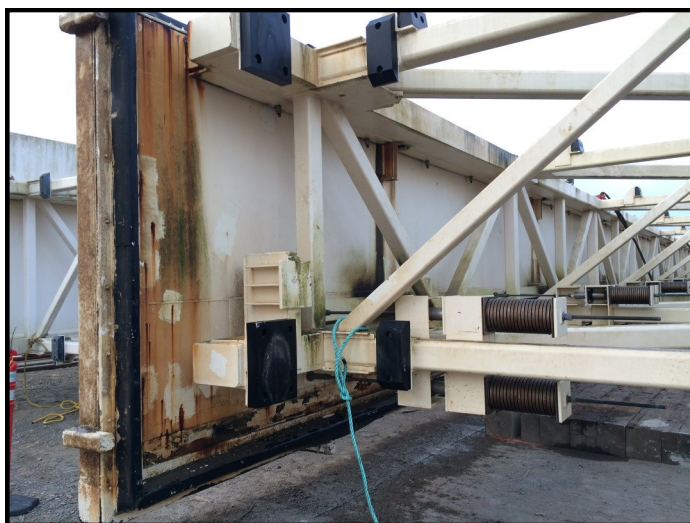
18) T1 butyl rubber held well. SS coating failure in addition to improper prep on previous repairs now failing.

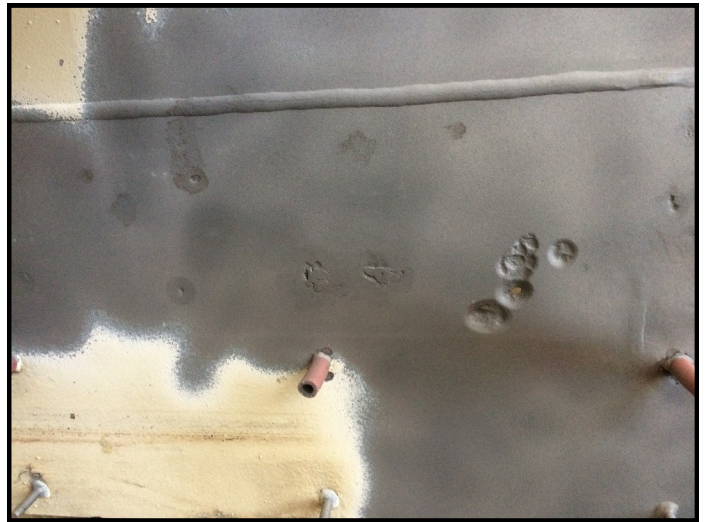
31) HCS intake plates primed and bent pick point tab replaced.

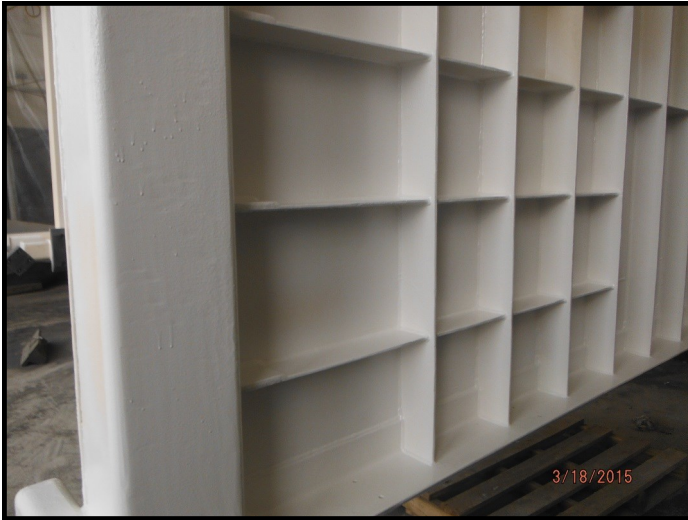
49) Front T1 Duraplate235.

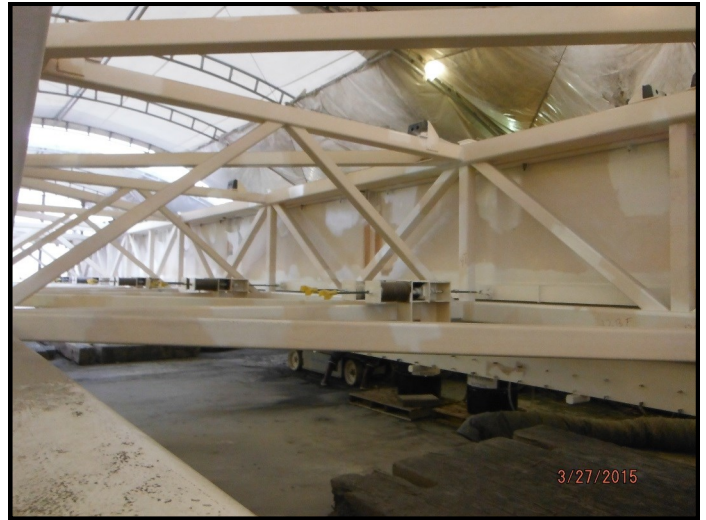
50) Back of T1 Duraplate235.

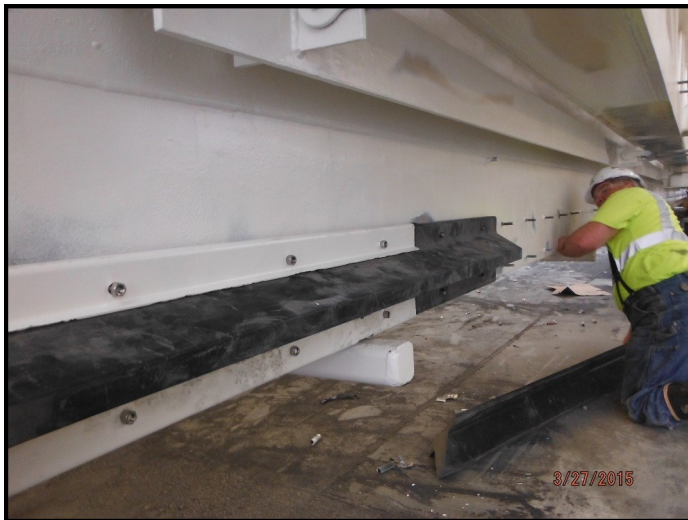
51) Seal replaced after 4 days min of cure.

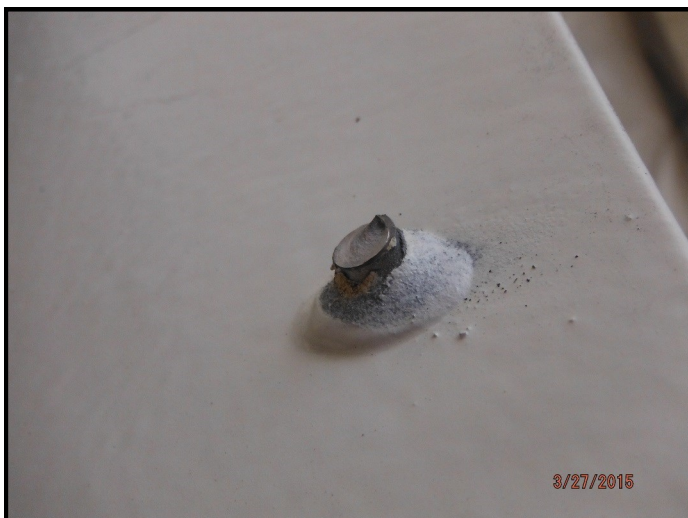
53) A stud sheared on GL1 T1 vertical seal during seal install.

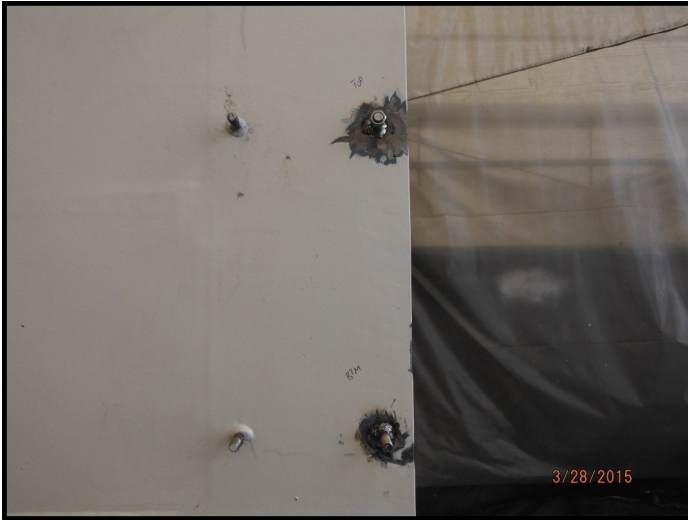
55) Both studs were removed and replaced with a new 316L SS stud.

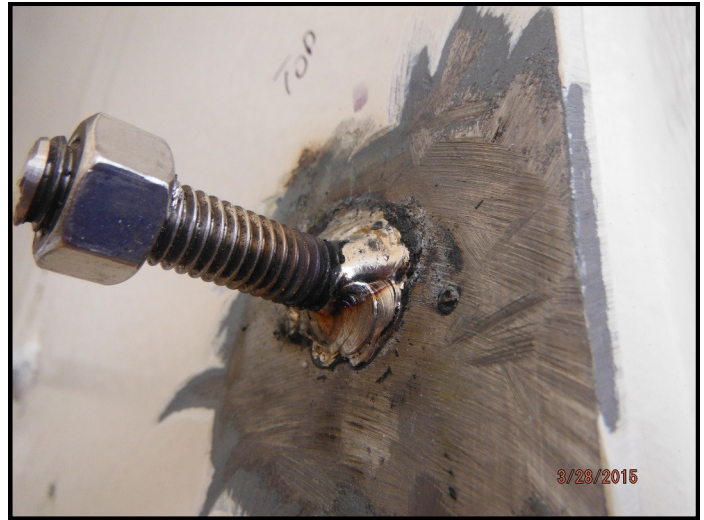
56) Close up of top SS stud.

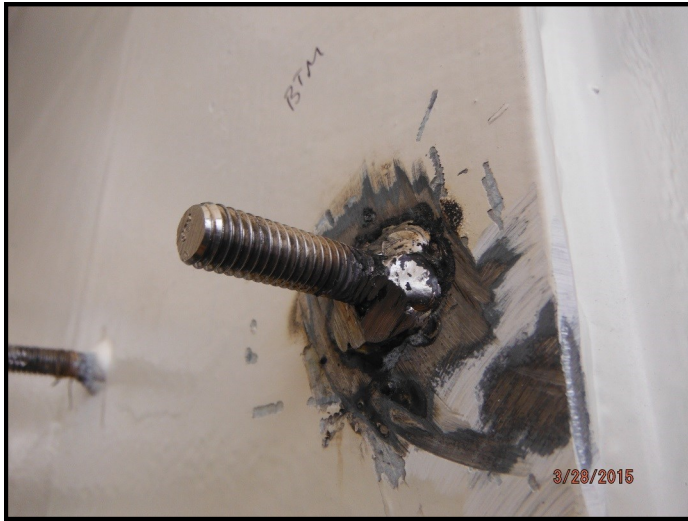
57) Bottom close up of SS stud.

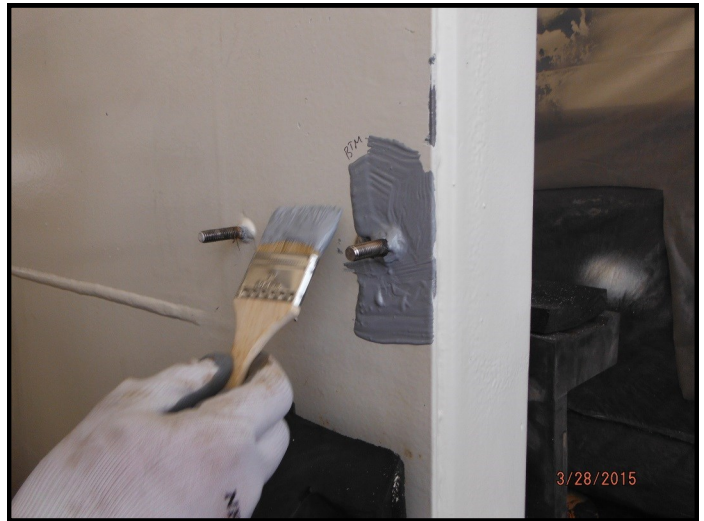
58) Fast Clad ER used for touch up due it the rapid cure.

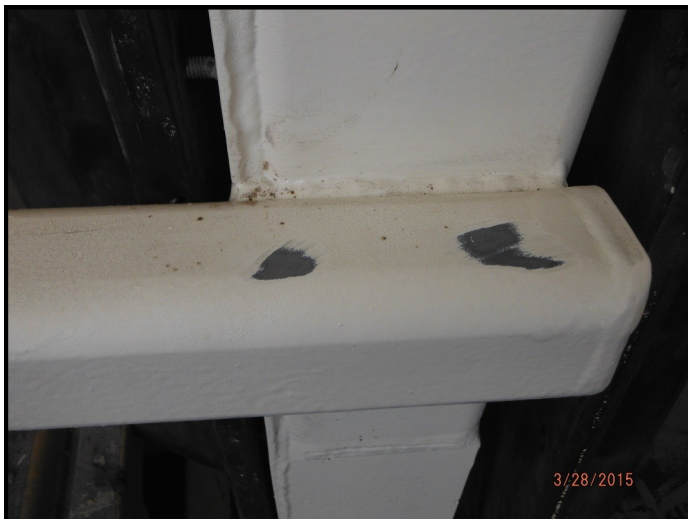
59) Spots where weld metal hit were also touched up.

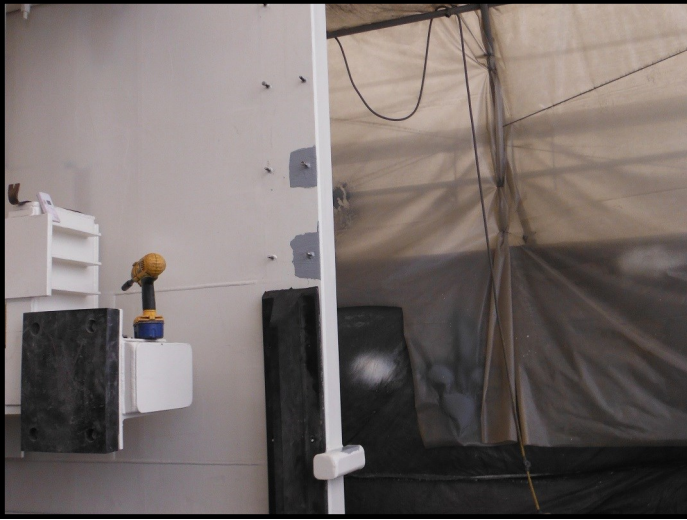
61) Stud repair area after paint.

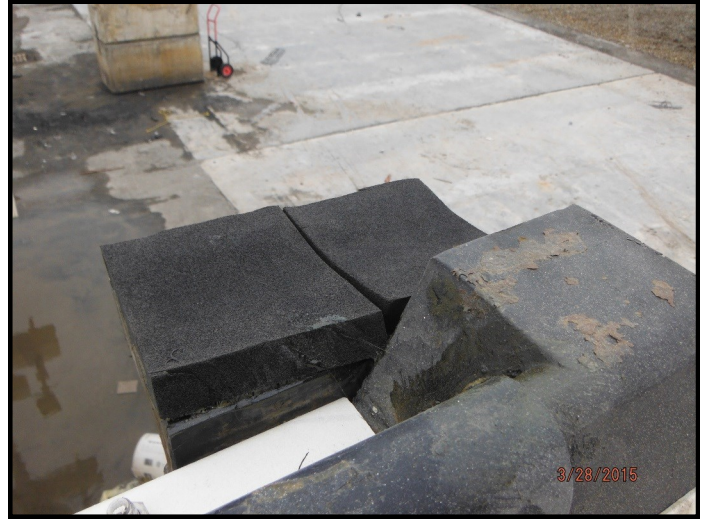
62) Intermediate seals with new 3/4" foam to aid in seal.

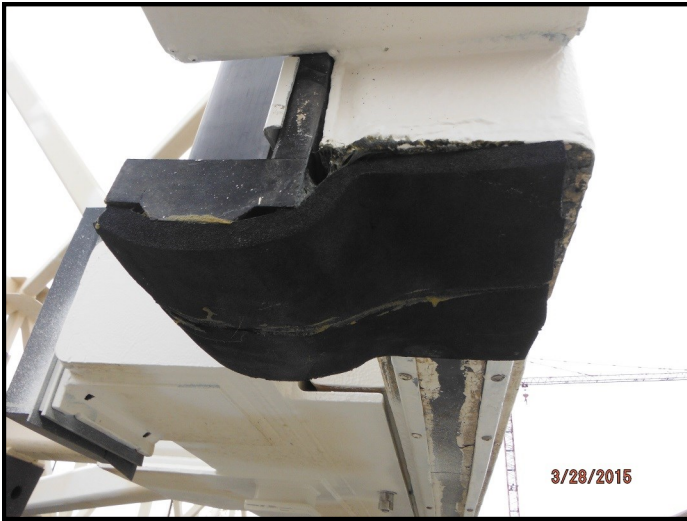
63) Intermediate seals with new 3/4" foam to aid in seal.

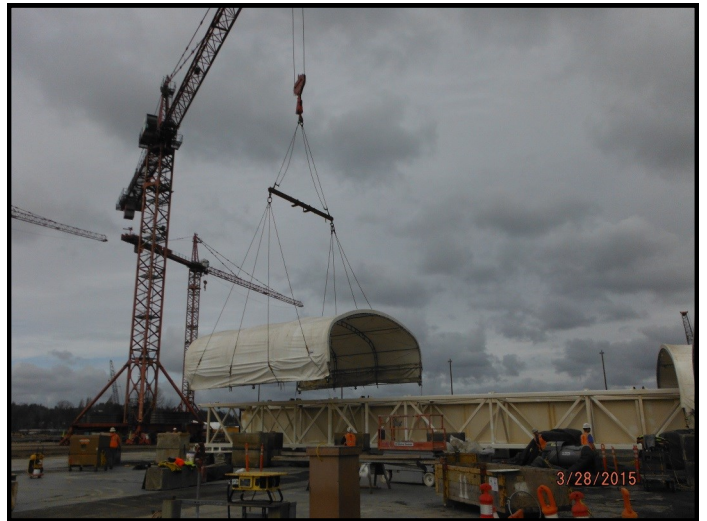
64) Tents removed after cure to service period of 5 days.

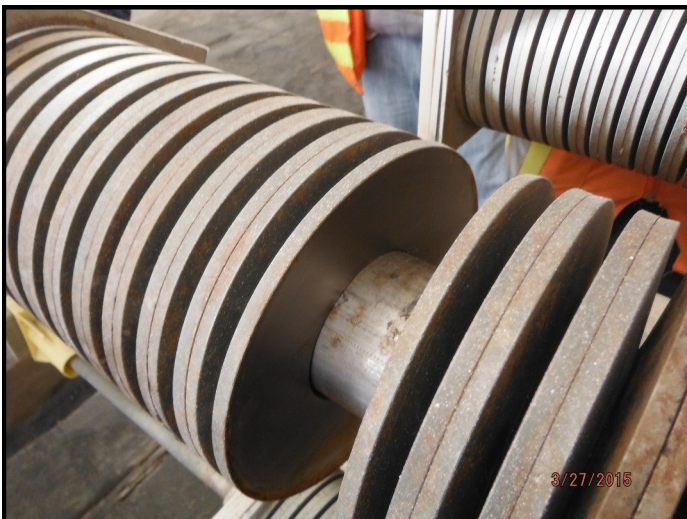
65) Top spring pack at 8.8T and top at 2T inspected to be okay. Light surface rust.

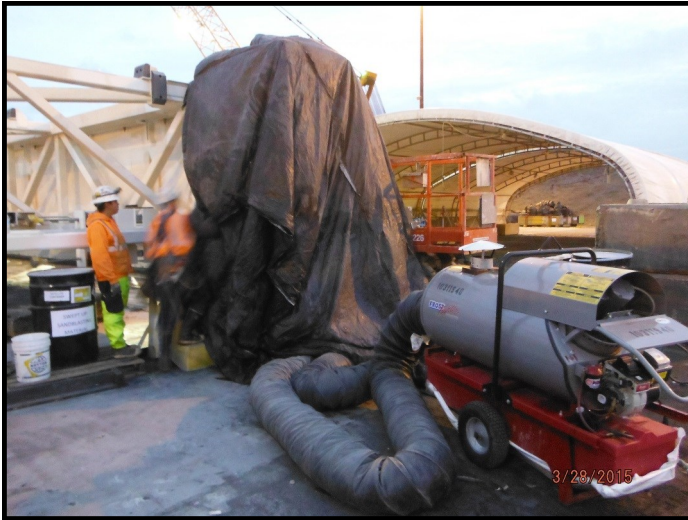
67) T1 stud shear area with 100deg environment to cure the Fast Clad ER in 12 hrs.

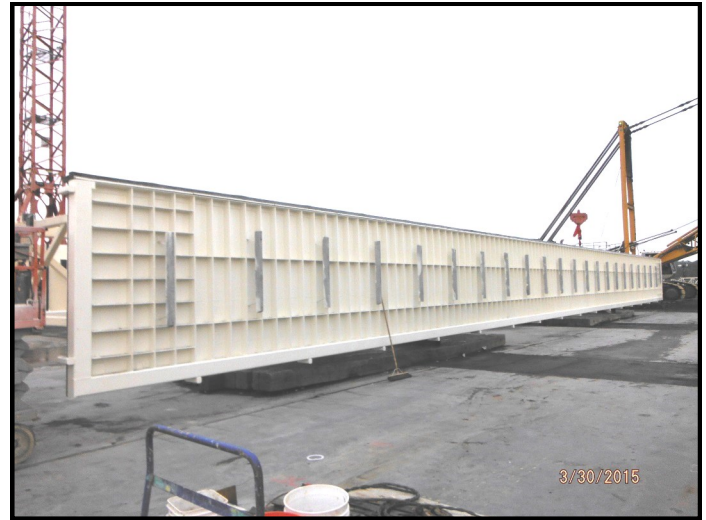
68) T1 final product.

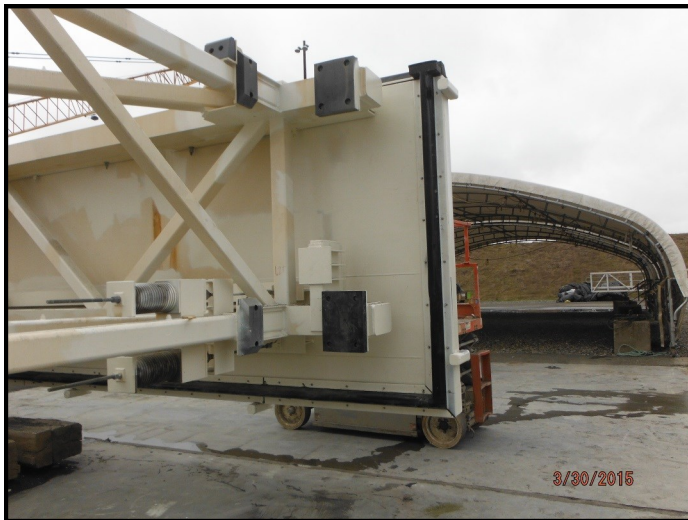
69) Stud repaired area with seal re-installed.

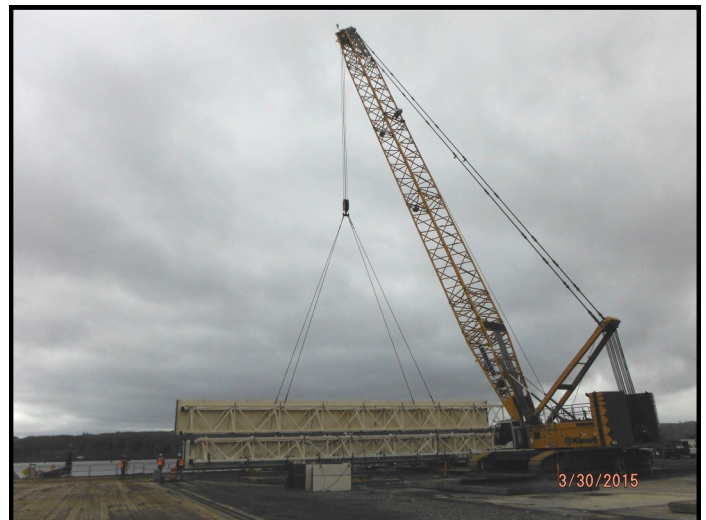
70) Gate moved back to dunnage on dirt.

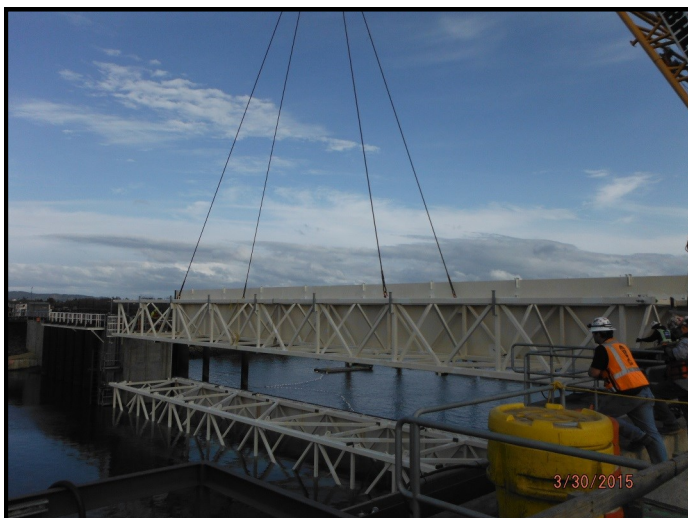
71) Gate reset on Monday March 30th, 2015 at 4pm.

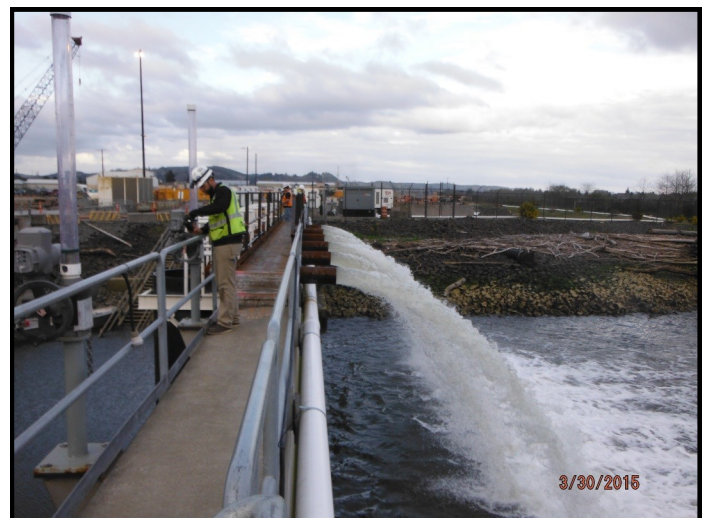
72) Dewatering basin started at 6pm.

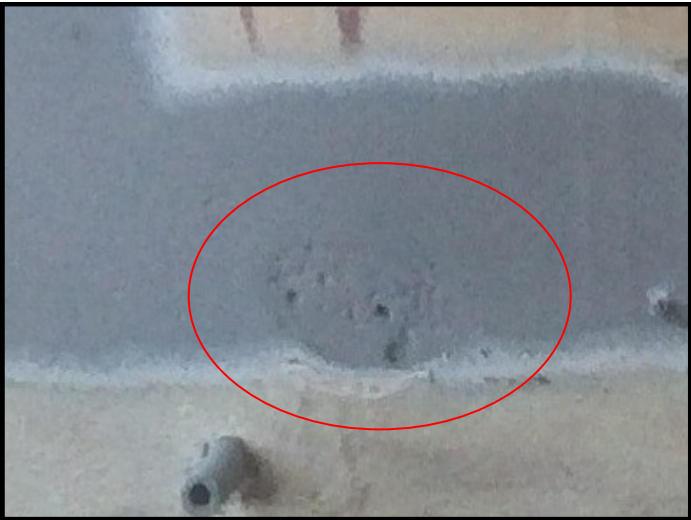
1 P

9T: 1/4" diameter x 1/8" pits existing repair

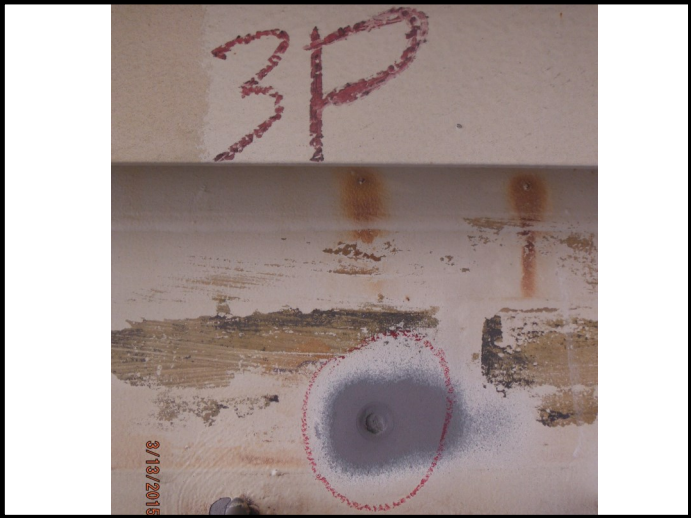
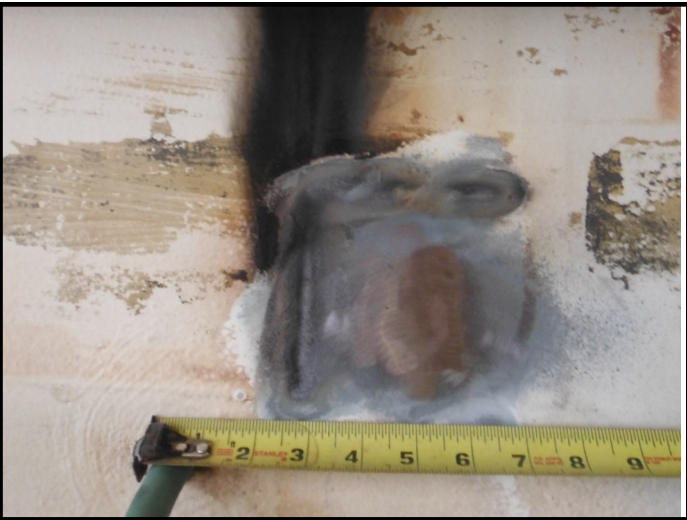
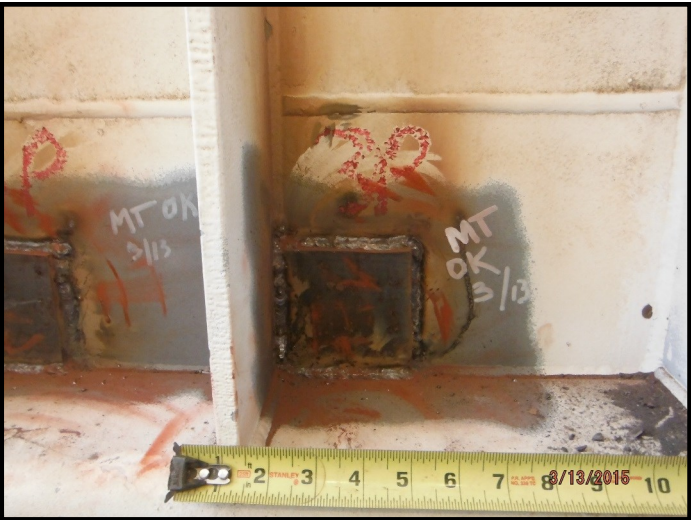
3 P

25" after Grid 8T: - 1" diameter x 3/16" pit

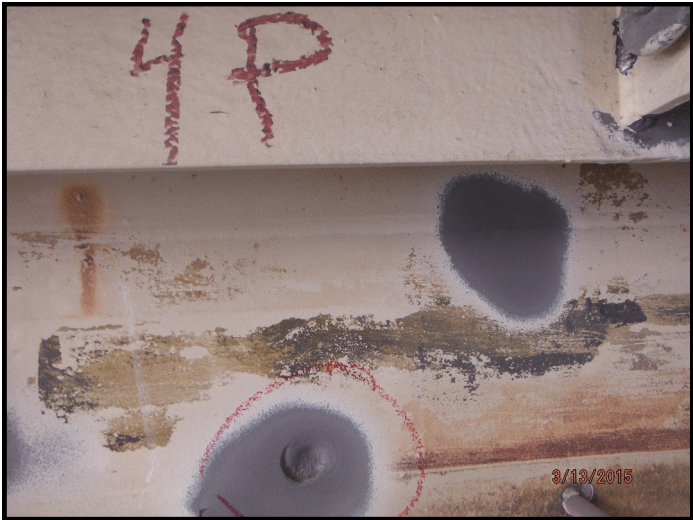
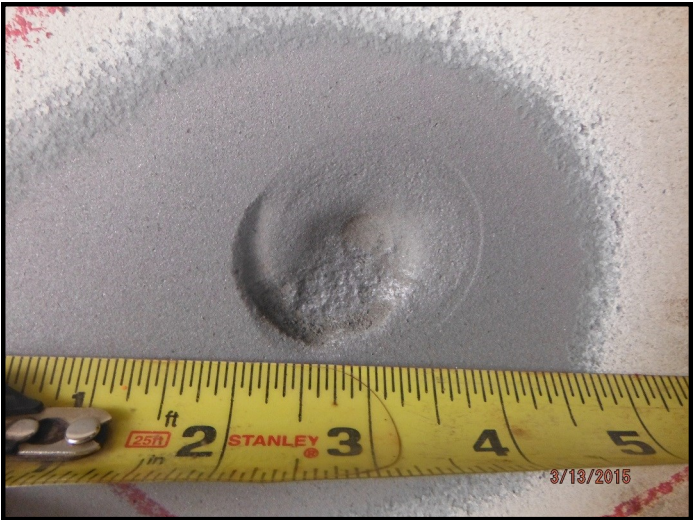
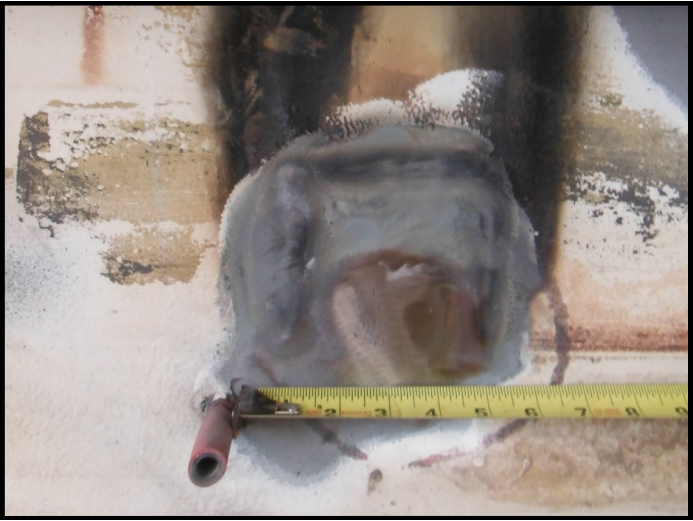
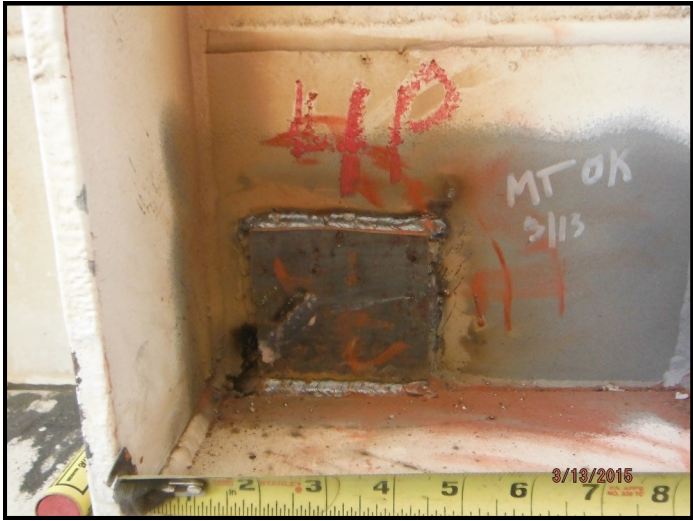
4 P

14" after Grid 8T: 2" diameter X 1/4" pit

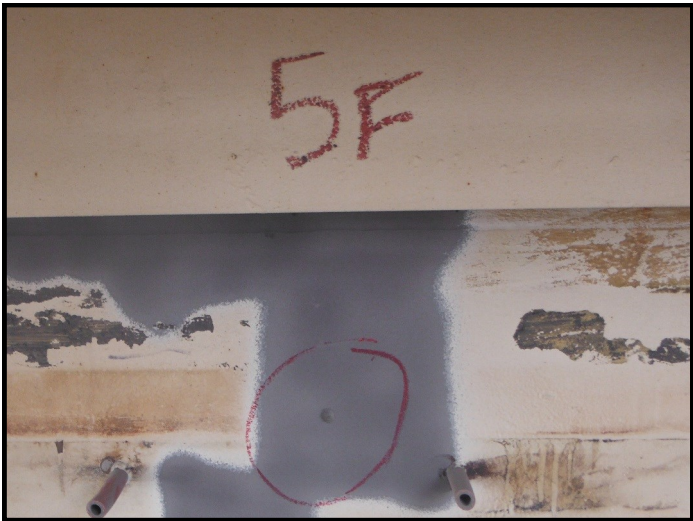
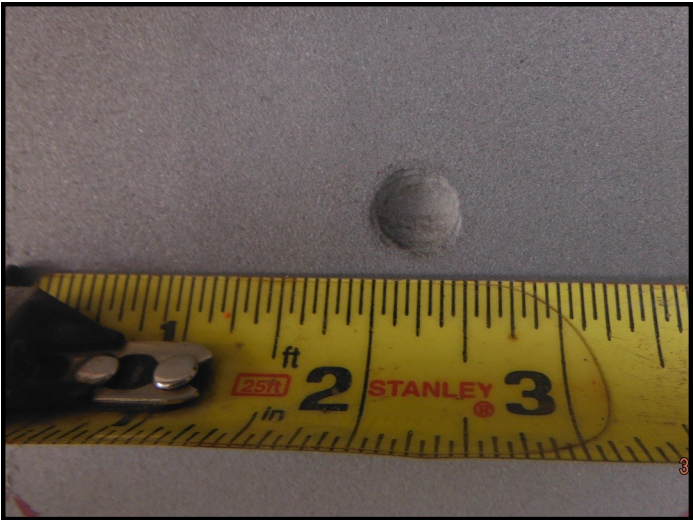
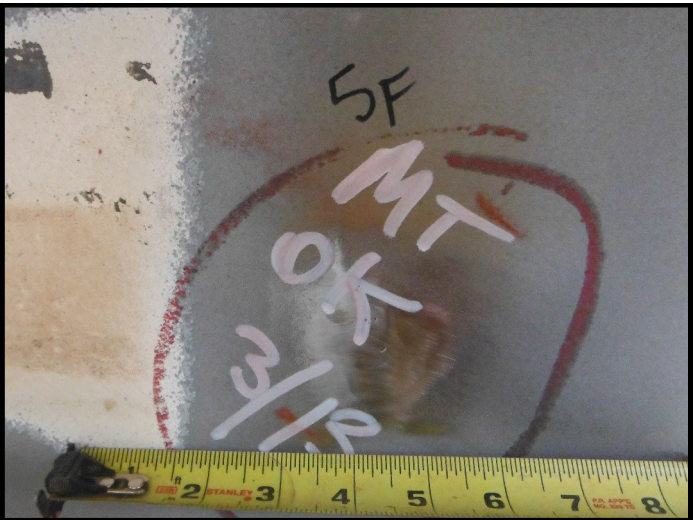
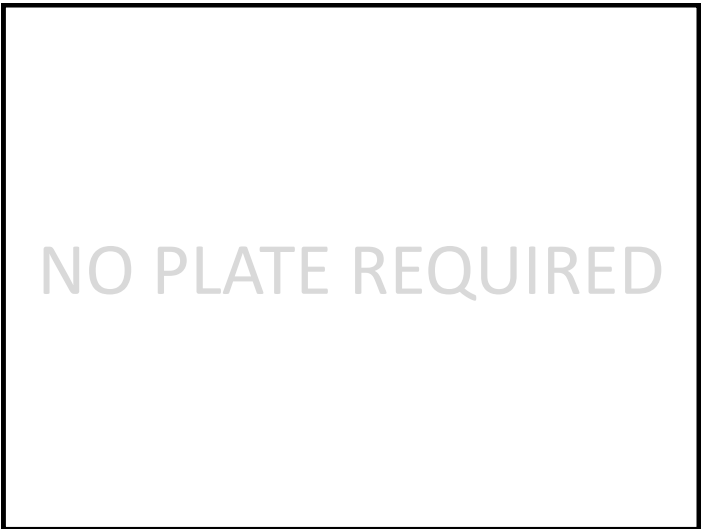
5 F

45" before Grid 8T: 1/2" diameter X 1/4" pit

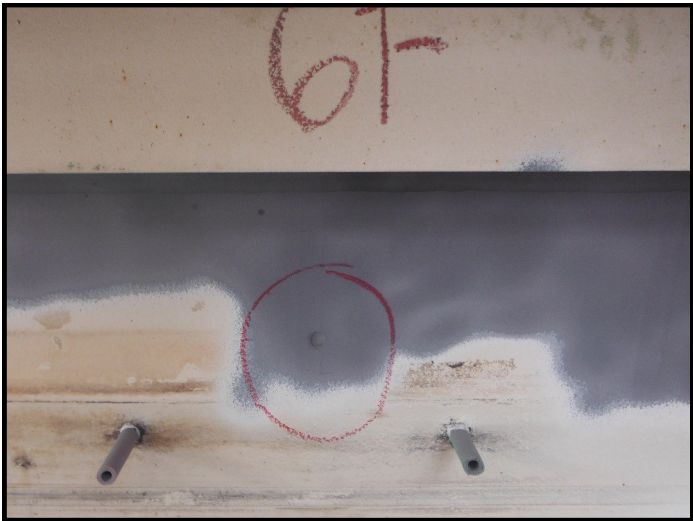
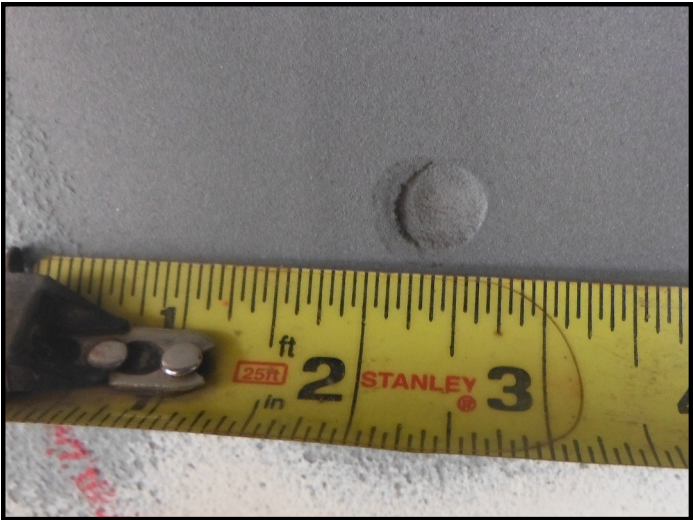
6 F

57" after Grid 8T: 1/2" diameter X 1/4" pit

NO PLATE REQUIRED

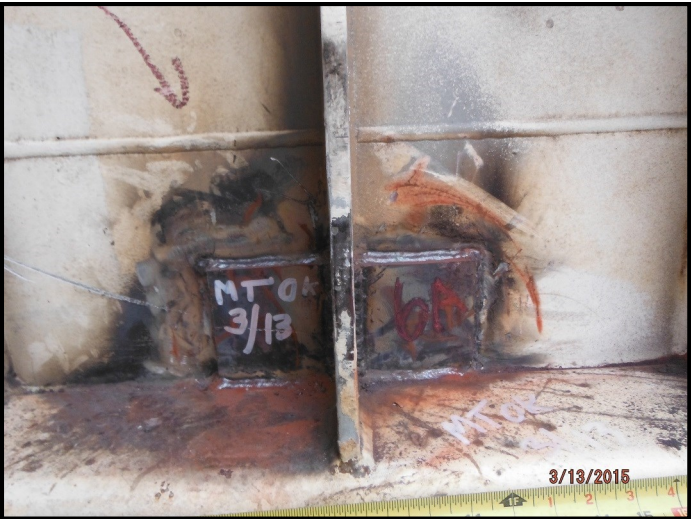
7 F

105" before Grid 7T: 1/4" diameter X 1/8" pit

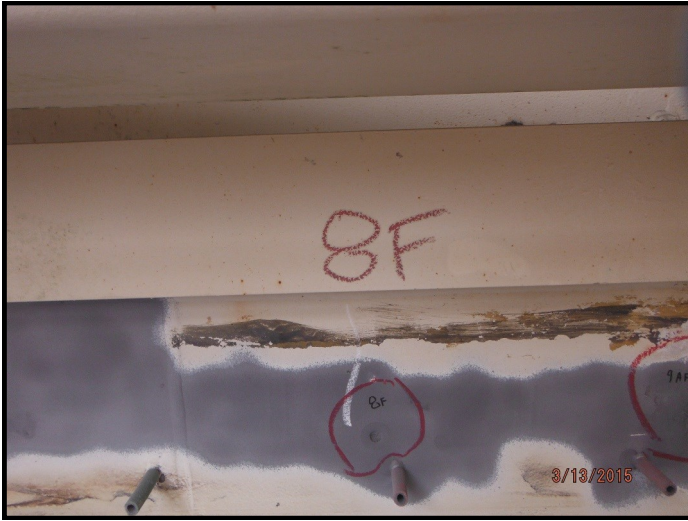
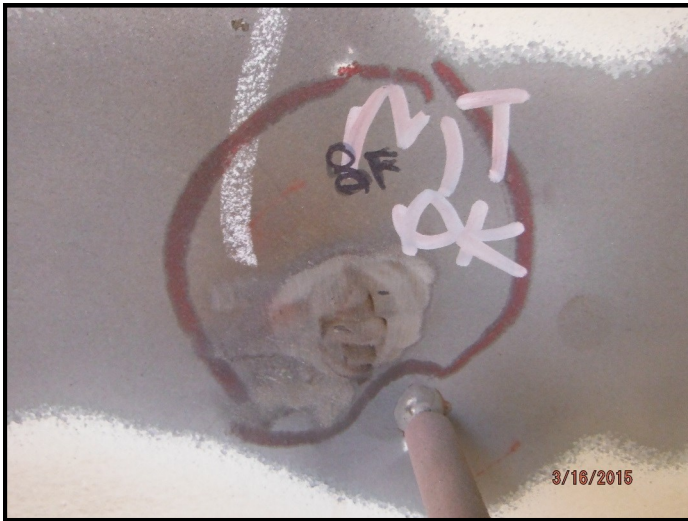
8 F

127" before Grid 7T: 1/2" diameter X 1/8" pit

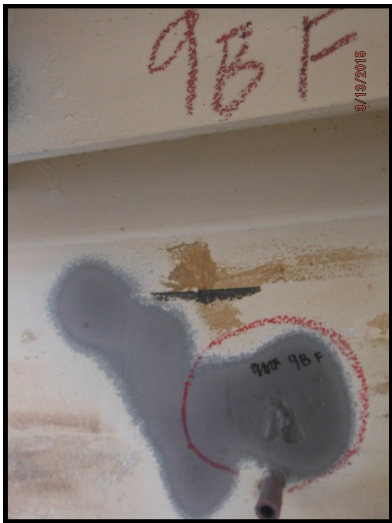
9B F

17" before Grid 6T: 1/2" diameter X 1/8" pit existing repair

NO PLATE REQUIRED

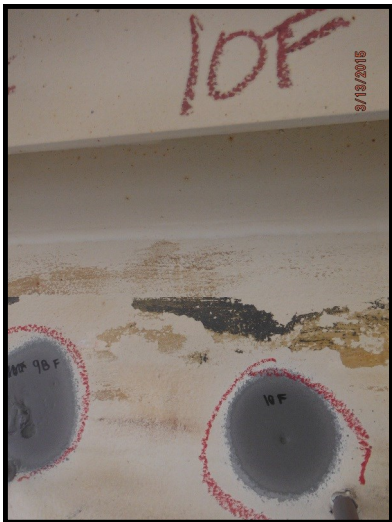
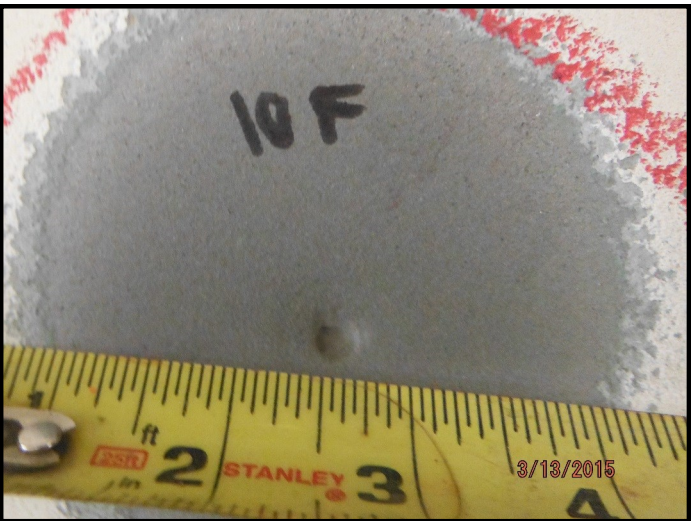
10 F

26" before Grid 6T: 1/4" diameter X 1/16" pit

NO PLATE REQUIRED

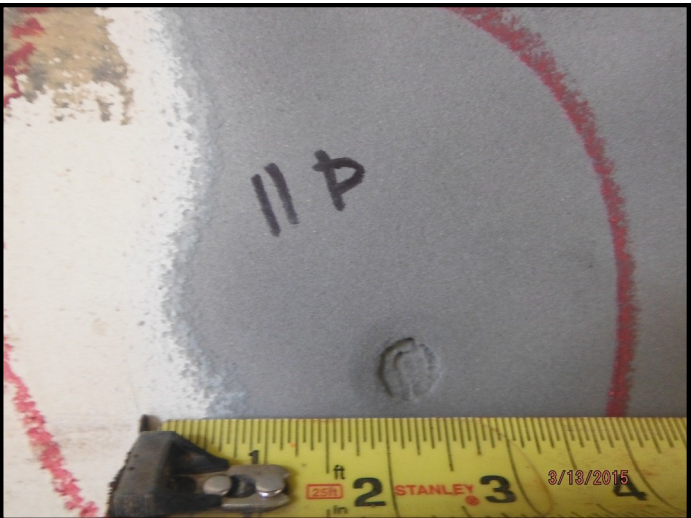
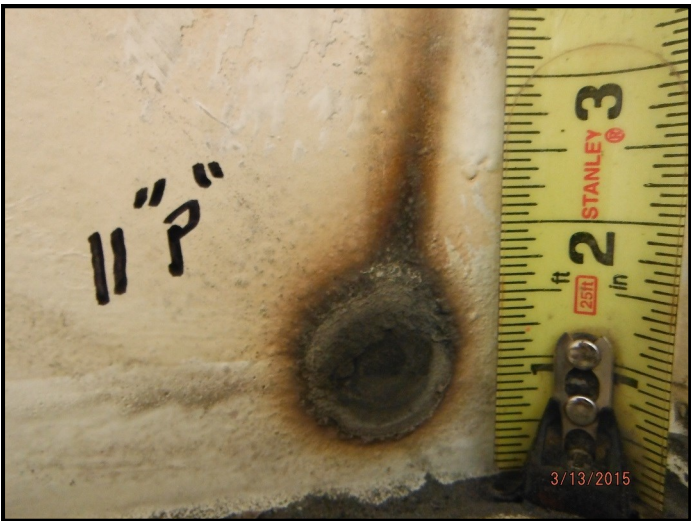
11 P

63" before Grid 6T: 1/2" diameter X 1/8" pit

Patch not used

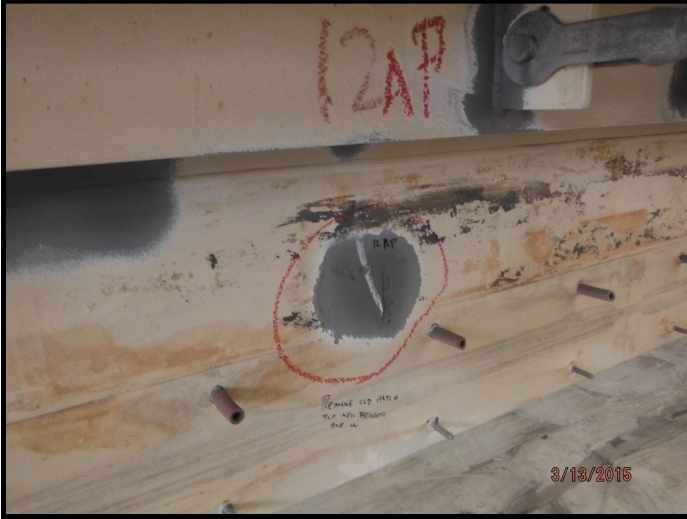
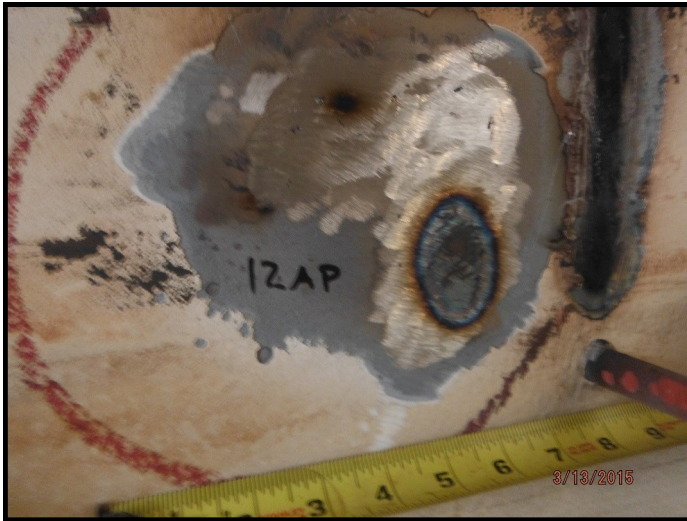
# 12A P

63" before Grid 6T: 1/2" diameter X 1/8" pit

Remove existing plate and add larger plate to extend 1" past repair

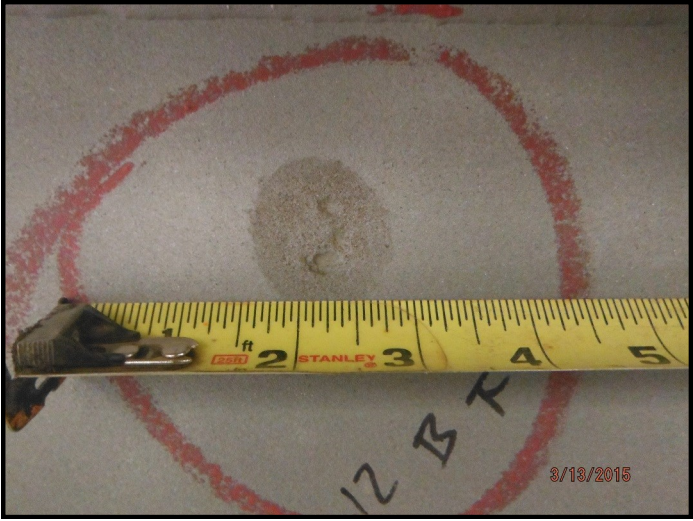
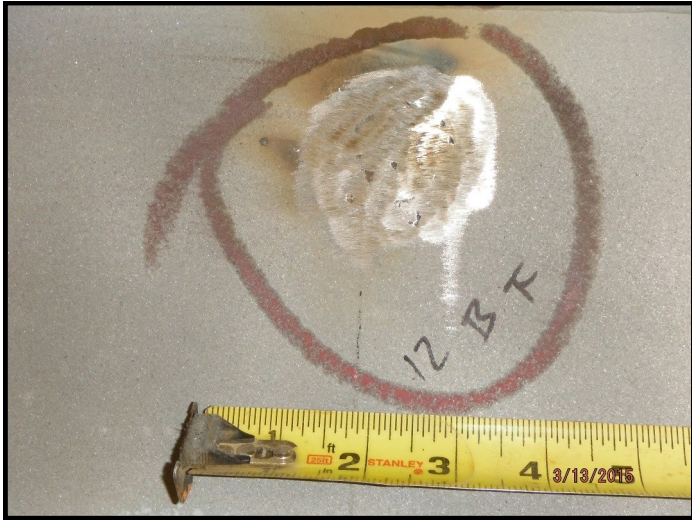
12B F

64" before Grid 4T: 1/2" diameter X 1/16" pit

NO PLATE REQUIRED

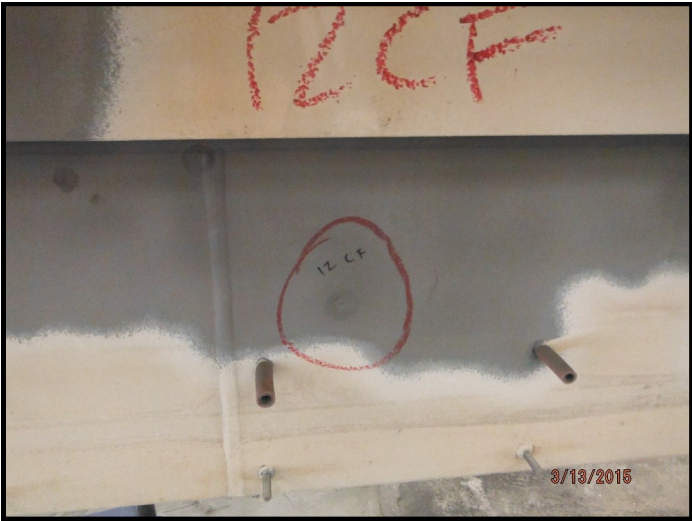
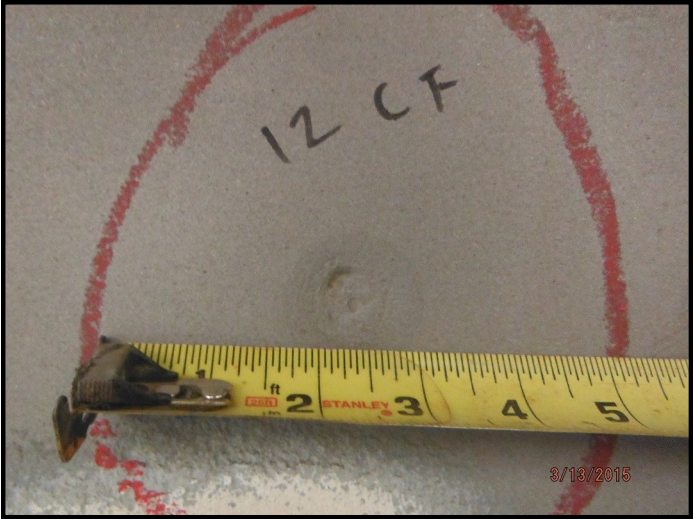
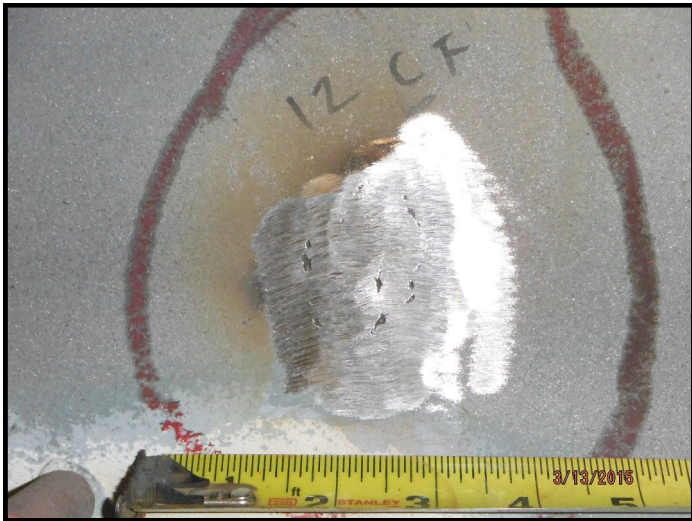
12C F

92" before Grid 4T: 1/2" diameter X 1/16" pit

NO PLATE REQUIRED

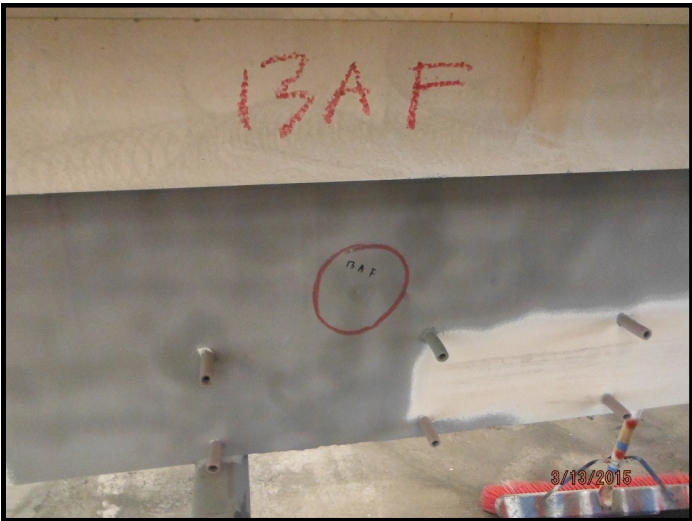
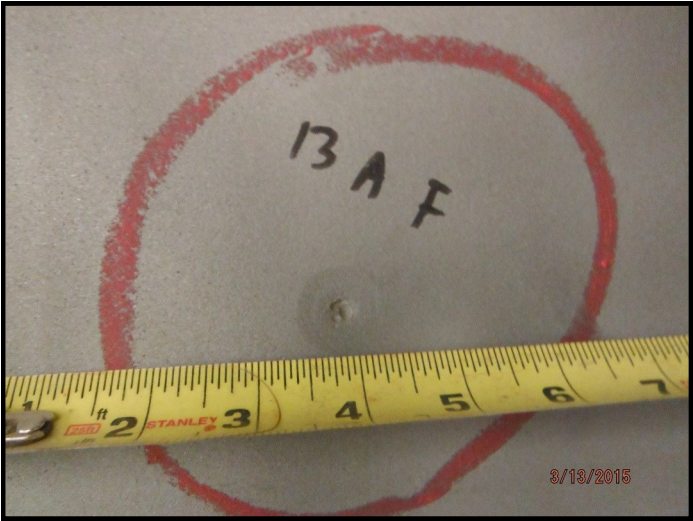
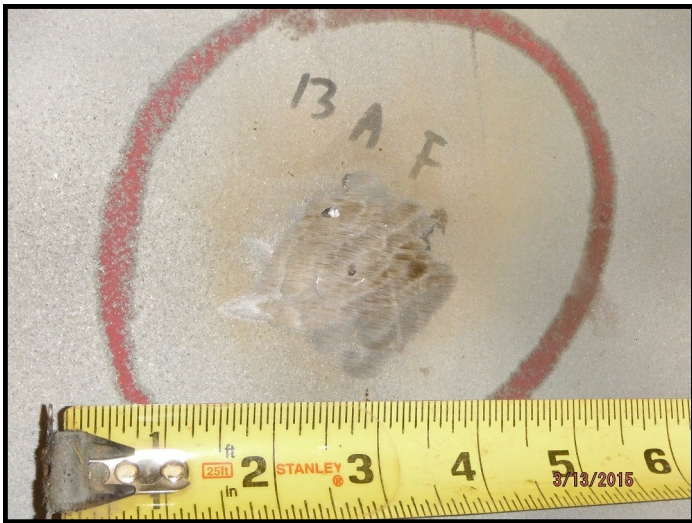
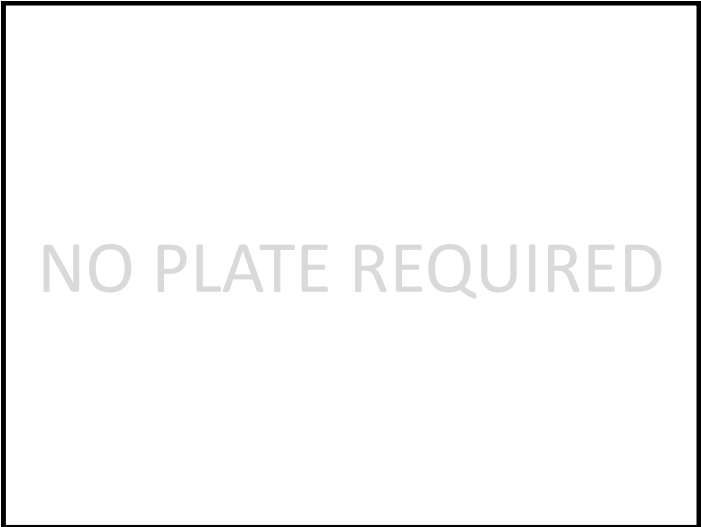
13A F

11" after Grid 4T: 1/8" diameter X 1/8" pit
